SERVICE BULLETIN

14-08-35

MODELS CONCERNED:

MK4 B, C, F & T Series Tractors.
B Series B60-4TRAC, B250-4TRAC, C50, C60, C80, F60-4TRAC, F250-4TRAC, T50, T60 & T80.

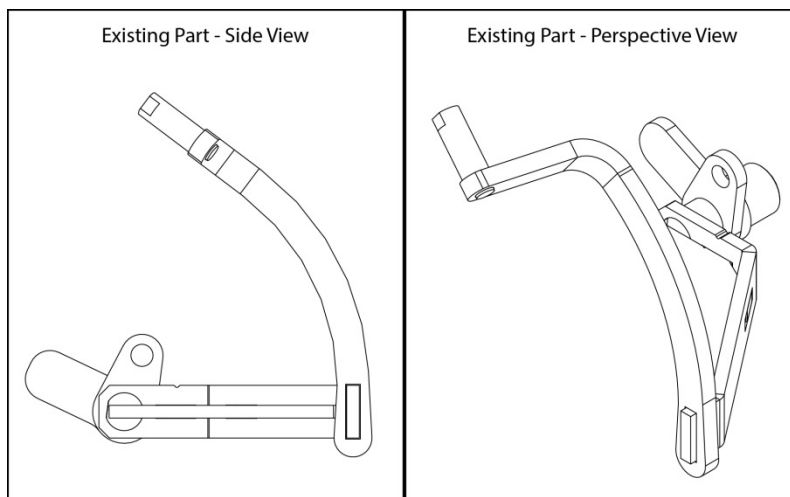
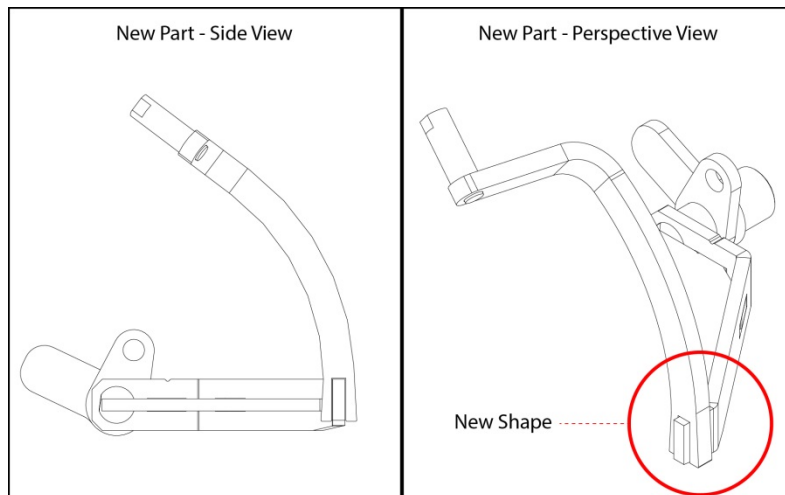
Identifying the Problem Part

A potential problem has been identified with the reverse foot pedal and 36 HGM drive pulley safety guard. When the deck lift mechanism is operated the two parts will clash at level 7. This issue will prevent travel beyond level 7 to level 9. It could also cause damage to the deck and reverse pedal.

A modified pedal assembly has been produced. The new part avoids contact with the deck. This part can be swapped with the existing assembly with minimal rework.

New Part Name	Part Number	Comment
Reverse Pedal Assembly	329650200	Part number unchanged (revised issue)
