SERVICE BULLETIN

15-08-37

MODELS: MK4 C, B, T, F – SERIES AND ECHO TRACTOR MODELS

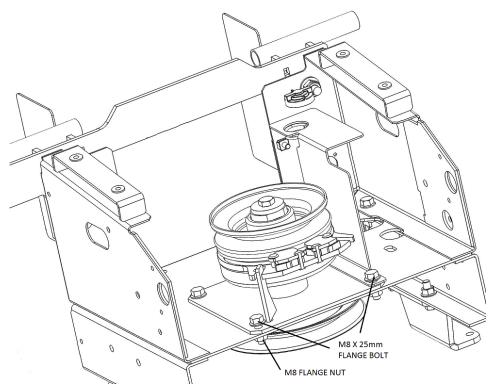
Fig. 1 Remove M8 Flange bolts and nuts.

- Please disconnect the battery, disengage the PTO switch and turn off the engine.
- Remove two M8 x 25mm bolts and M8 flange nuts in PTO clutch assembly as shown in Figure 1.
- ➤ Assemble the PTO clutch stop bracket(549129800) and M8 x 40 hex bolt/flange nut as shown in Fig.2
- ➤ Line up the PTO clutch stop bracket assembly with the existing holes on the Chassis and the Anti-rotation slot in PTO clutch as shown in Figure 3.
- > Secure the bracket with existing M8 X25 Flange bolt and M8 Flange nut as shown in Fig. 3.
- Ensure the clutch has both axial and radial free play at minimal level. (refer fig. 4)
- ➤ Please reconnect the battery, turn on the Engine and engage the PTO clutch and ensure the clutch is free from rattling noise.

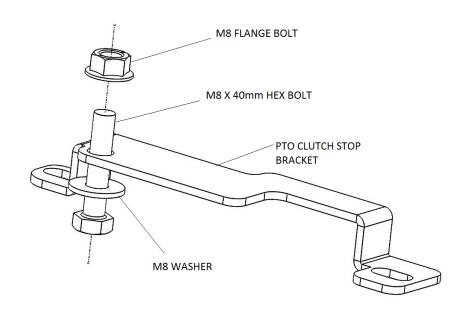
Fig. 2 PTO Clutch stop bracket assembly.

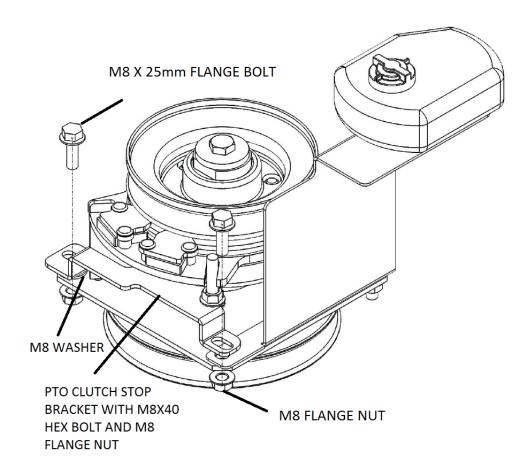
Fig. 3 PTO clutch stop bracket assembly.

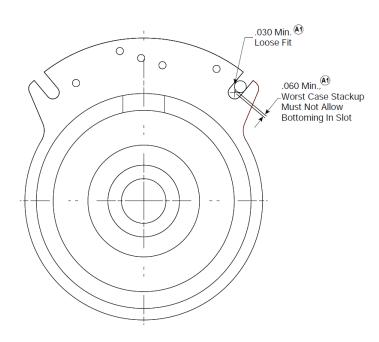
Fig. 4 Anti Rotation reference guide (Dimensions in Inch).
